## 1.0 BUILDING DESCRIPTION

Department of Public Works Building  
Structural Evaluation and Code Compliance Review

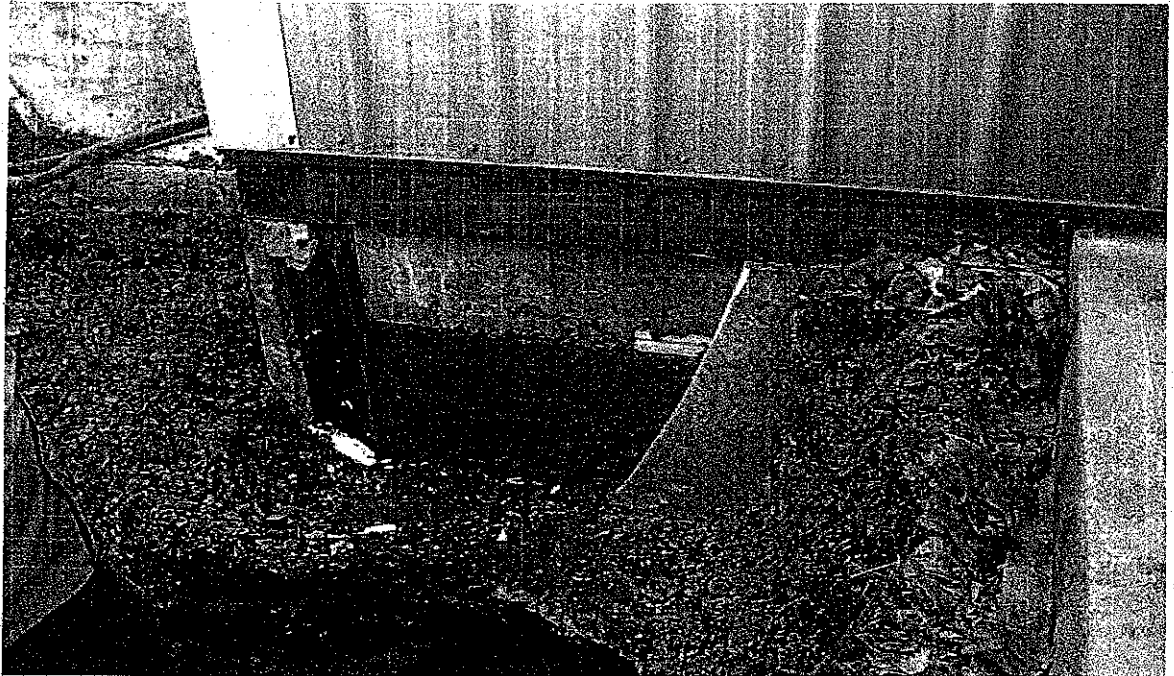
1. The existing structure was built with a concrete pour strip (serving a spread footing) and below grade wood structural elements exposed to constant moisture through the Item No.4 stone fill layer found between the 12" concrete floor/base slab and the concrete pour strip below. Refer to Detail 2 on Drawing A-4 of the As-Built Drawings.
2. 6" x 8" Glulam posts were observed at all three test pit locations. These posts proceed from the roof line to a 2" x 8" sill plate that is attached to the concrete pour strip. The foundation sill plate anchorage was observed to be comprised of a post-installed, small diameter fastener of an unknown or irregular spacing. The posts are toe nailed into the sill plate with no other form of fastening observed. A 3" thick layer of Styrofoam insulation board was observed to be the only barrier between the earth and wood

posts (See Photos 1, 2 and 3). No other form of preservative or protective coating was observed on the wooden foundation components.

**Photo 1 - West Elevation, North Corner - Foundation Test Pit**

3. The concrete pour strip/ strip footing appears to have been poured in place against the surrounding soil and no evidence of steel reinforcing was observed. The footing varies in thickness with an approximate maximum depth of 16". The footing was also observed to project irregularly from the exterior face of the building at a width between 12" to 16" and at a bottom depth of roughly 3'-8" to grade. This meets minimum frost depth.

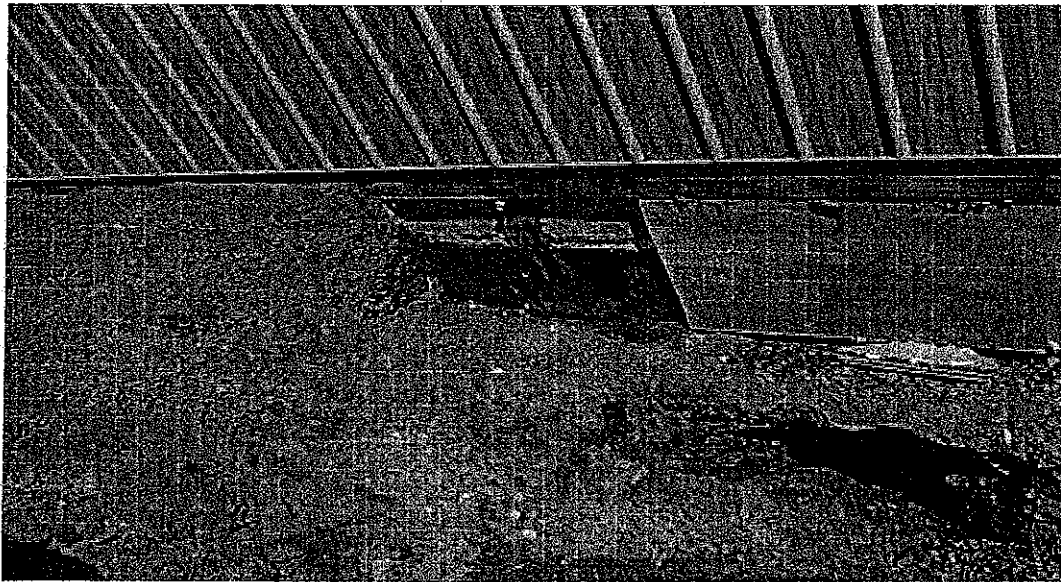
4. In general, there appears to be no substantial evidence of settlement of the foundation. The 1'-0" thick base slab and the continuous concrete pour strip (serving a spread footing) below did not reveal any visible cracking or observable deflection. However, it is advised that the foundation be monitored regularly for settlement and that a detailed geotechnical evaluation be performed.

5. Concentrated loads on the high bay garage door posts are supported by a strip footing that is not adequate to distribute the load to the soil below, based upon test pit inspections and loading evaluations conducted.

Photo 2 - Southern Elevation - Foundation Test Pit

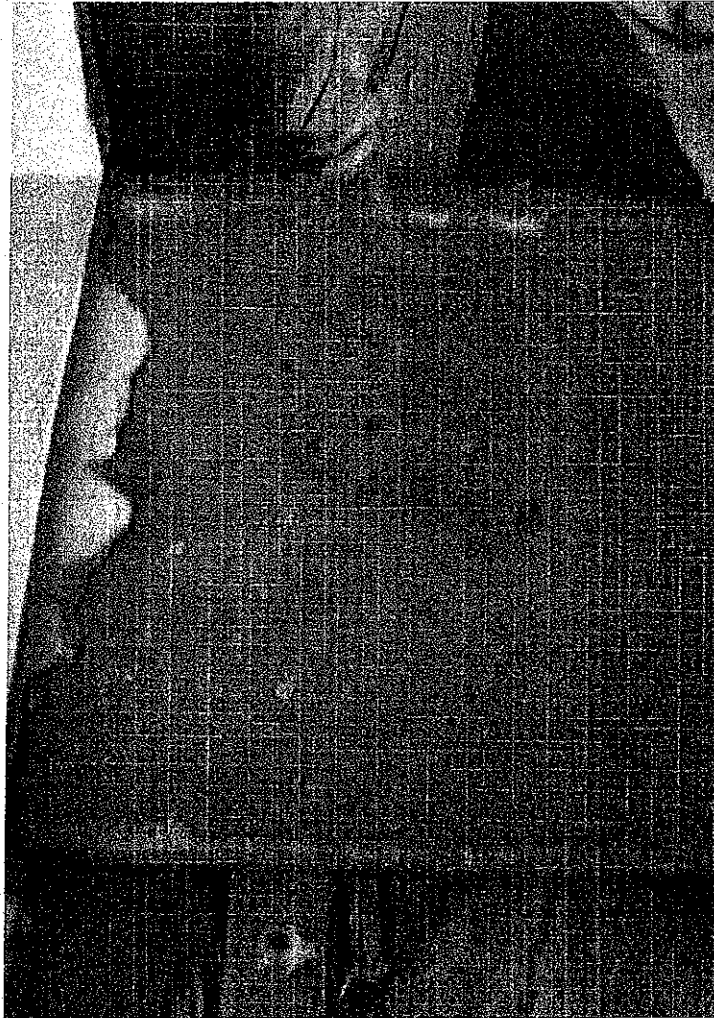
2. The double 2x12 LVL header system, (2) 2"x12" LVLs, is inadequate to support the load over both the 12' and 14' wide doors.

**Photo 5 – Typical 2"x12" LVL connection to 2"x8" stud.**

3. The typical double 2x12 LVL header around the building is adequate to support the load away from the garage doors; however, the connection to the studs is inadequate. The connections were found to be made by 16d common nails, (8) eight nails on either side (inside and outer – 16 nails total).
4. The 6X8 glulam jamb post is inadequate to support the load at the garage door openings, and the connection to the post is inadequate to transfer the

1. The building's structural system, including its foundation be reinforced to support all loads in compliance with the New York State Building Code. The primary concern is the lateral force resisting system be addressed as soon as possible. The connections for the support members should be re-designed.
2. Continuous monitoring of the building for short term and long term settlement.
3. A fire separation barrier between the two building uses should be constructed.

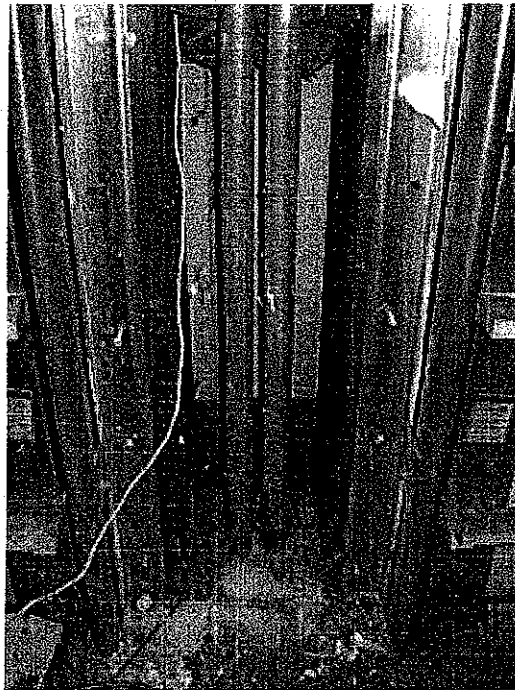
load. Again, utilizing only common nails – no lag screws or through bolts were observed during our investigations.

5. There is no adequate code recognized means of lateral load transfer, roof diaphragm, or shear walls.

Photo 6 – 6"x8" Glulam posts at west garage doors

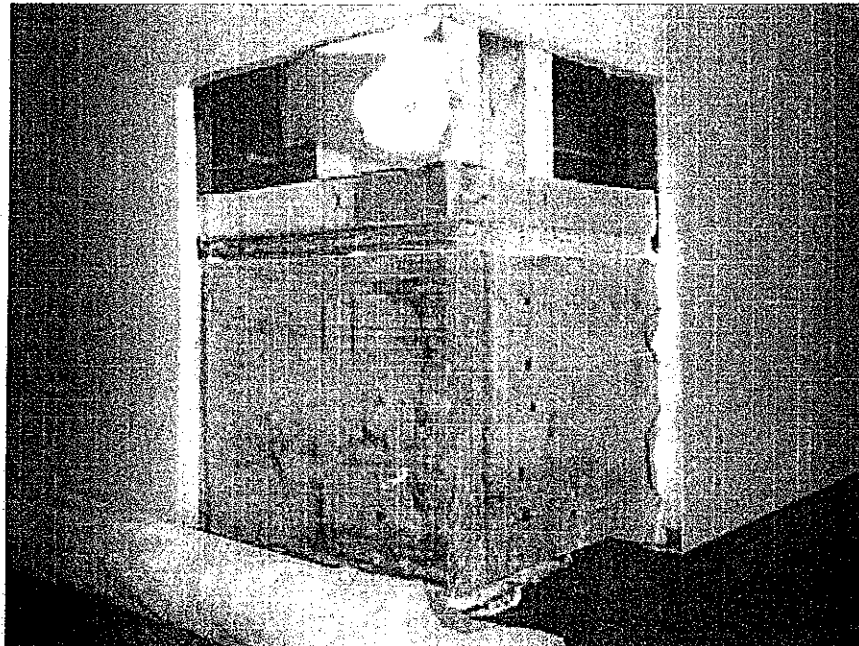
6. A portion of the framing at the west mezzanine is inadequate, including the double 2x12 headers and the stud wall supporting the cantilever section.
7. The southern mezzanine double 2"x10" header framing between the lally columns is inadequate for a storage mezzanine design load.
8. Lally columns do not have independent foundations. They bear directly on the 12" floor slab with no positive connection at their respective bases. In addition, some bear directly on the floor slab construction joints.

**Photo 7 – Exposed southwest corner of South Storage Mezzanine**

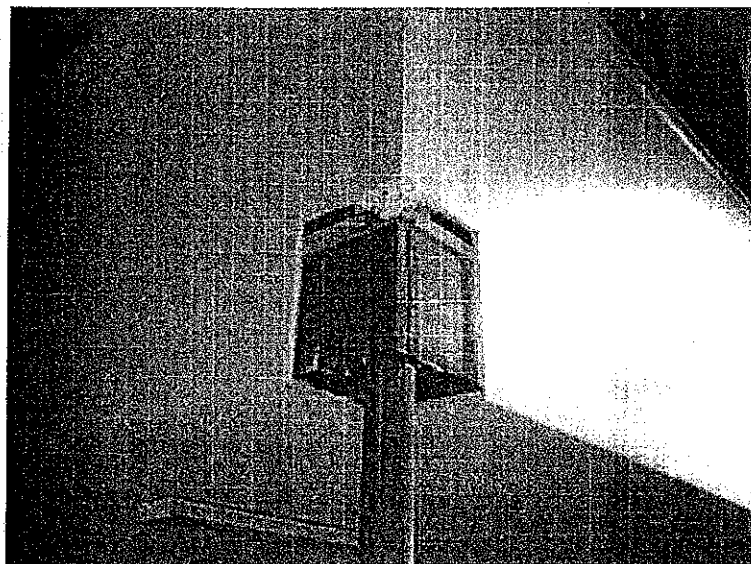
**Photo 8 - Exposed southwest corner of West Storage Mezzanine**

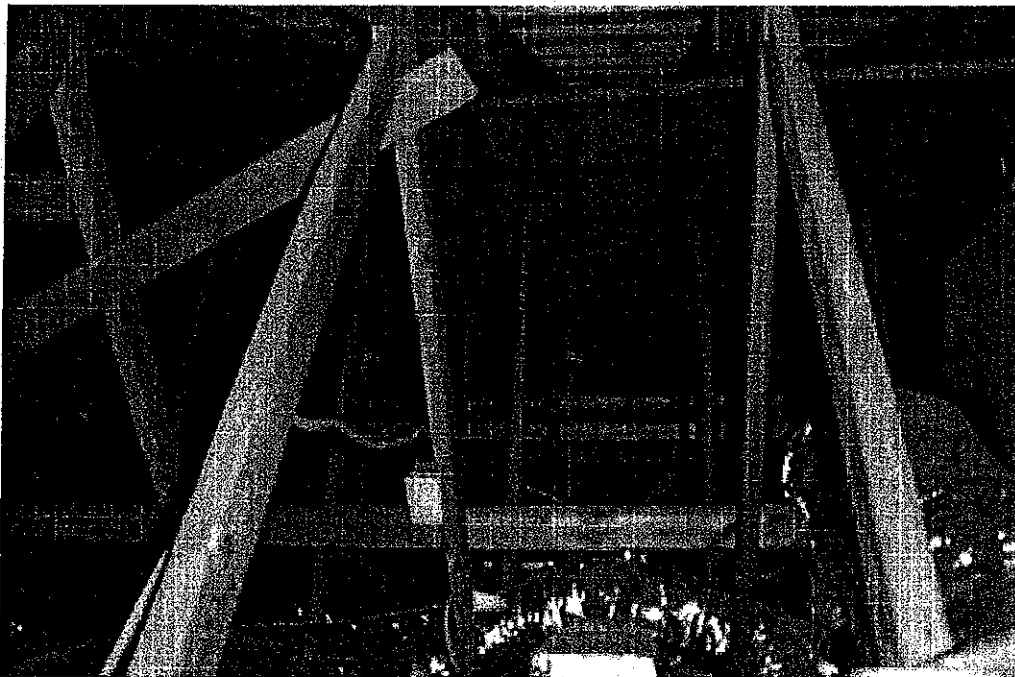
1. One line of 2"x4" bracing was found to be non-continuous during the inspection of the existing prefabricated roof trusses. This is not installed per the original truss manufacturer's specification. In addition, there are four more bracing lines needed to address the wind uplift condition on the truss.
2. A positive connection was determined to be provided from each truss to either a glulam post or 2"x8" wall stud and is sufficient to resist the uplift forces.
3. No underlying sheathing was observed below the exterior corrugated metal roofing.

**Photo 9 - Roof truss framing as taken from Attic facing west, near 2nd floor Office access stairs.**

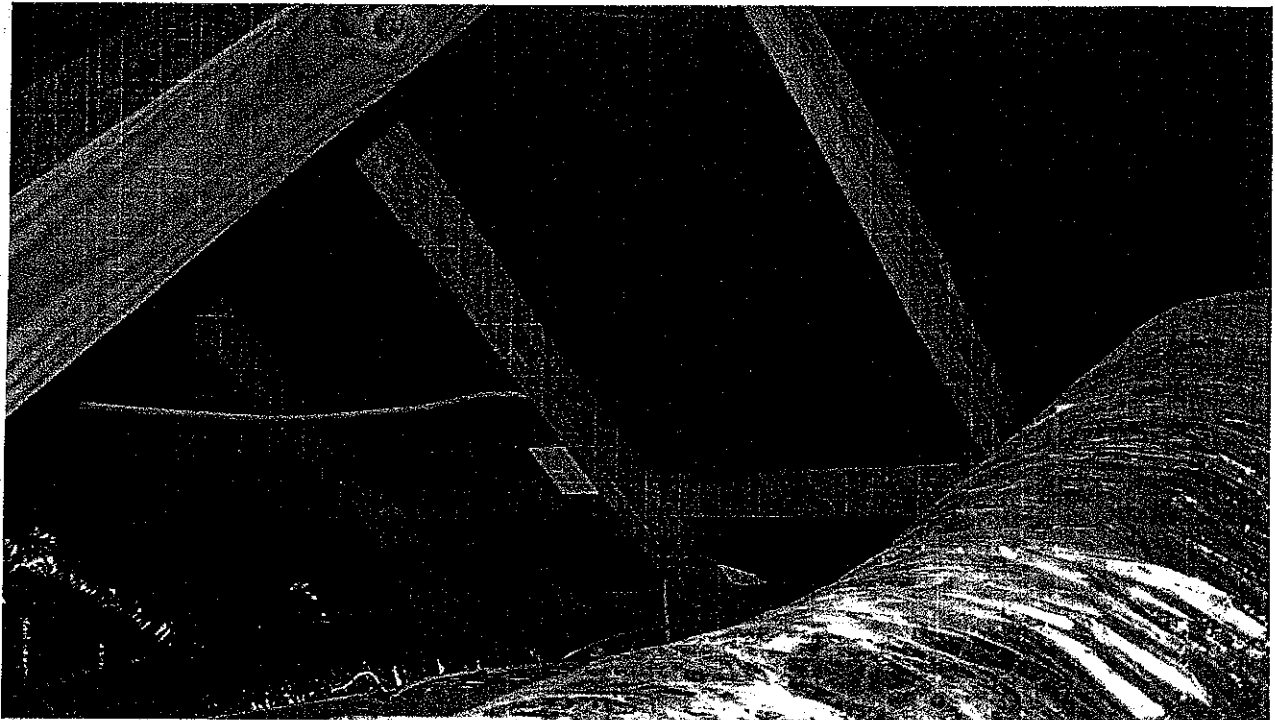
Photo 10 - Roof truss framing as taken from Attic facing northwest.
